# **Damage to wood-beamed roofs of biogas tanks – causes, experience and recommendations**

## **Summary**

During the last a little less than four years the author examined damage (collapse) of wooden roofs of vessels (digesters, post-digesters, digestion residue stores) of 21 biogas plants. The lifetime of these plants in the federal states of Mecklenburg-Western Pomerania, Brandenburg, Schleswig-Holstein, Lower Saxony and Rhineland-Palatinate was between 5 months and 9 years.

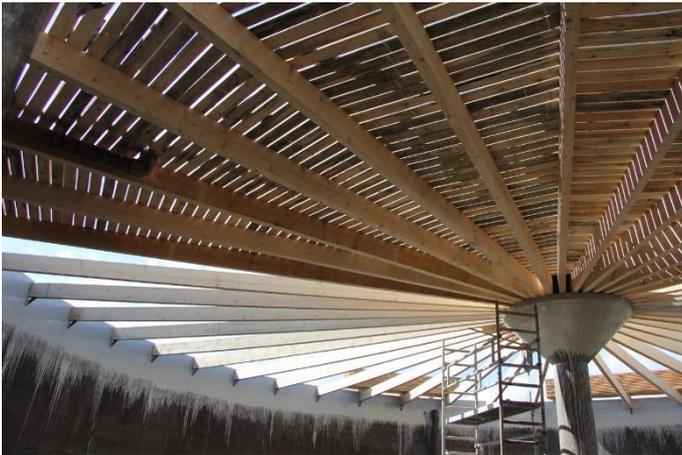
Figure 1: Inside view of a digester under repair

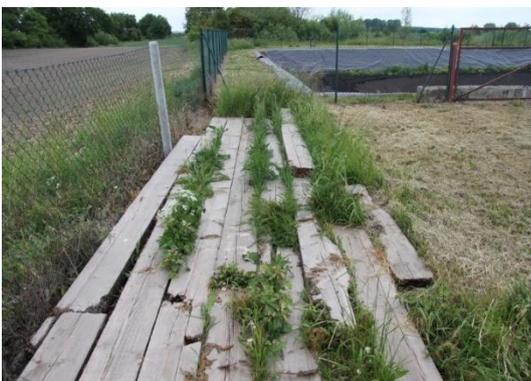
Breakage of three rafters after a service period of about 6 years. Another four rafters broke when the plastic film roof was removed for repair so that the complete roof on the digester had to be replaced in February 2012. Inspection in May 2012. Because broken rafters could be seen in the sight glass of the second digester, that roof was also replaced in August 2012. The timber parts from that second digester roof were examined by Prof. Claudia von Laar, Hochschule Wismar. The results of the examination available so far have, in part, been published in [4], [6] and [8] and can be downloaded from the author's homepage.

Figure 2: View of the broken rafters from the digester

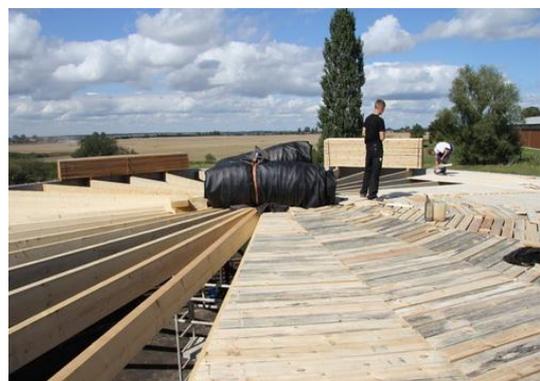
Figure 3: New roof on digester 2

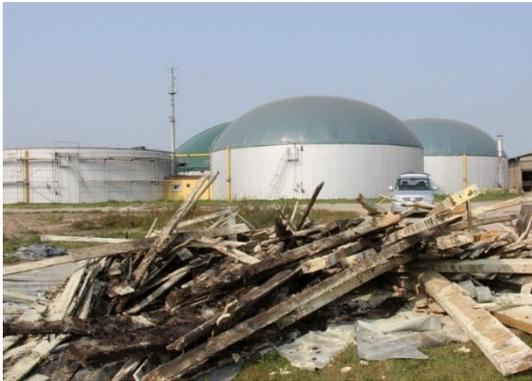
Figure 4: View of the demolished rafters from digester 1

Slippage of a rafter off the holder system at the vessel edge of the digester after a service period of about 5 years in May with the consequence of the gradual failure and fall of further rafters to the complete collapse when Padelgigant engaged the formwork/fleece layer. Breakage of more rafters during removal of the structure. Inspection at the time of removal in July 2013, published in [7] and [11]. Serious stability defects.

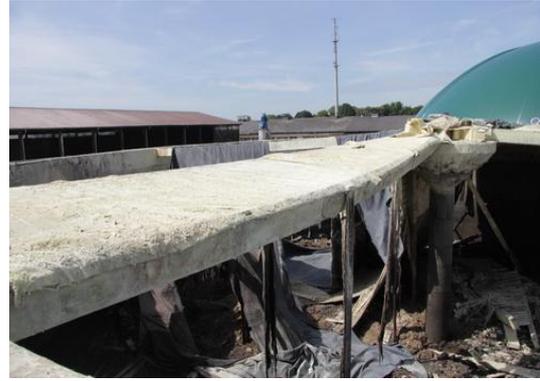
Figure 5: View of the digester after the collapse/partial removal

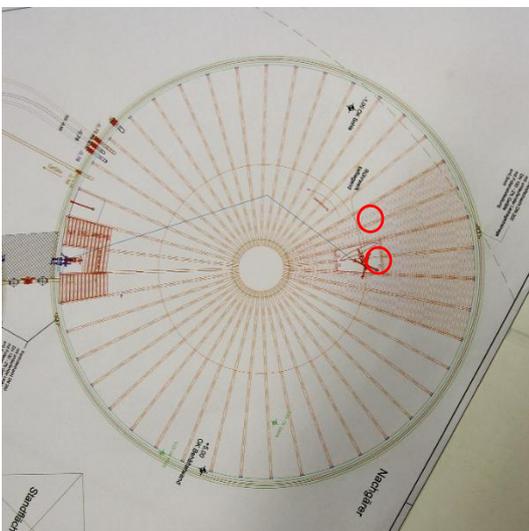
Breakage of totally 6 rafters in the area where rafters were changed after about 3.5 service years in connection with the removal of the plastic film roof after a power failure in October 2013. The rafter change had been planned so that not the complete roof structure had to be removed when the stirrer needed repair or replacement. No stability calculation available for the rafter change.

Figure 6: Sketch of the post-digester; the red circles mark the points where the rafters broke

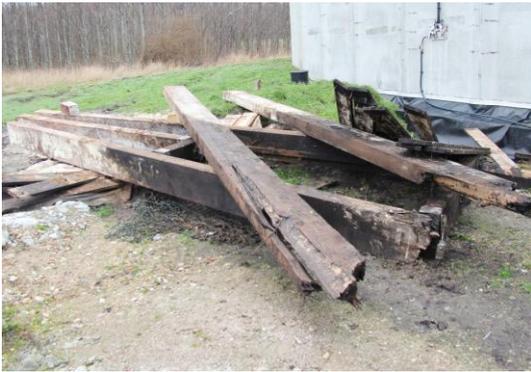
Figure 7: Rafter breakage at the change point

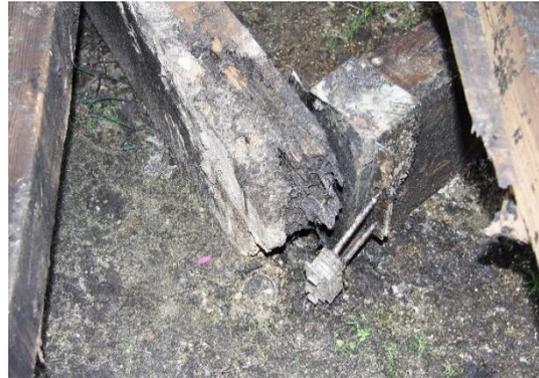
Figure 8: Detail of the broken rafter

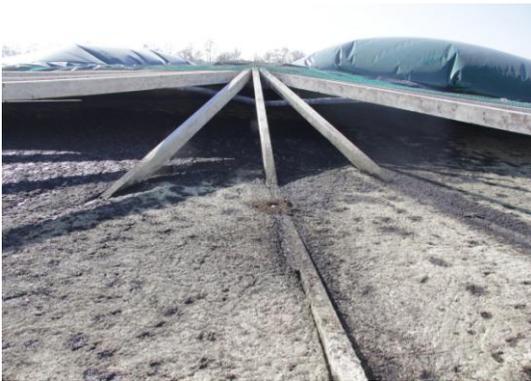
Breakage of 3 rafters (another 2 rafters partly broken) of a digester residue store after only a few months of service (after a storm).

Figure 9: View of the breakage point after opening it

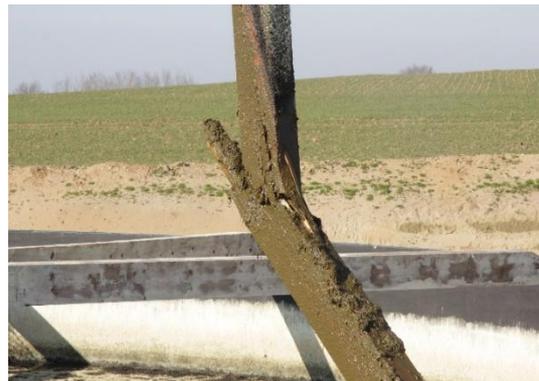
Figure 10: Recovery of a broken rafter

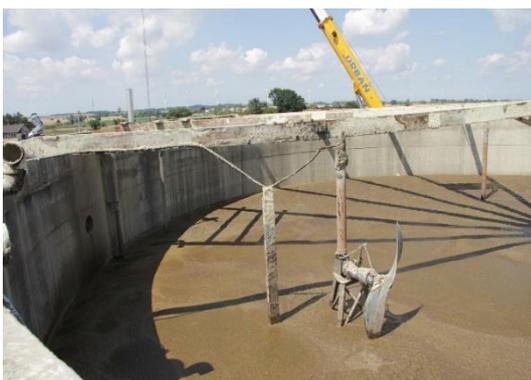
Breakage of a rafter in a digester in the area of a working platform after 2.5 years service. The platform serves for necessary work (e.g., replacement) of the stirrers beneath.

Figure 11: View of the breakage with remains of the working platform

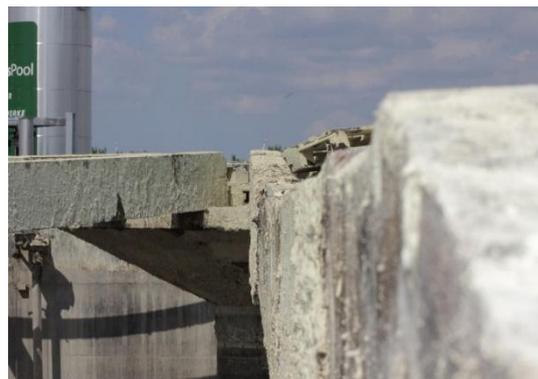
Figure 12: Visible sag of the rafter in Figure 11

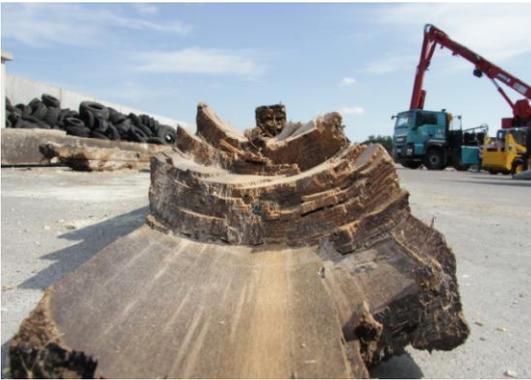
Figure 13: View of the point of breakage

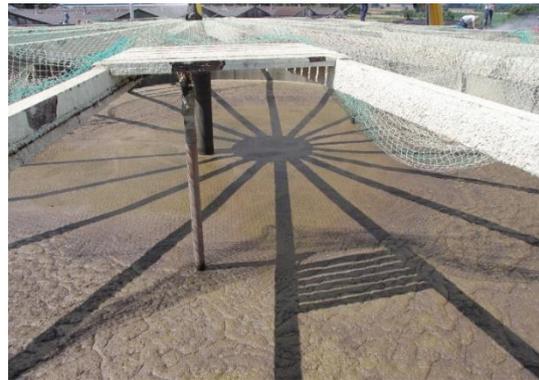
Figure 14: View of the second working platform

No available stability calculation of the rafters with the working platform.

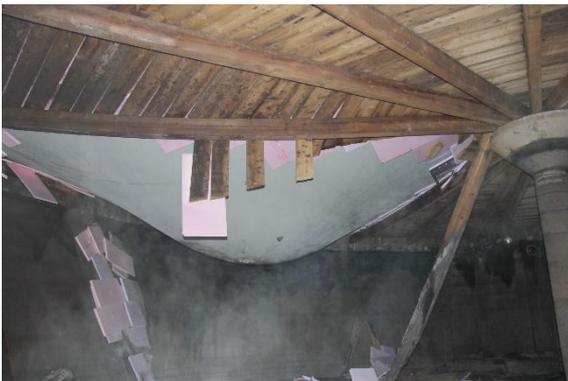
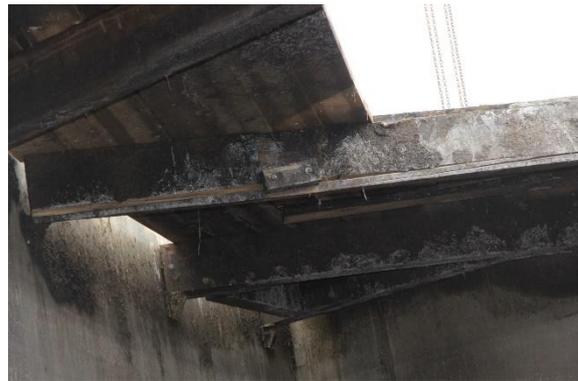
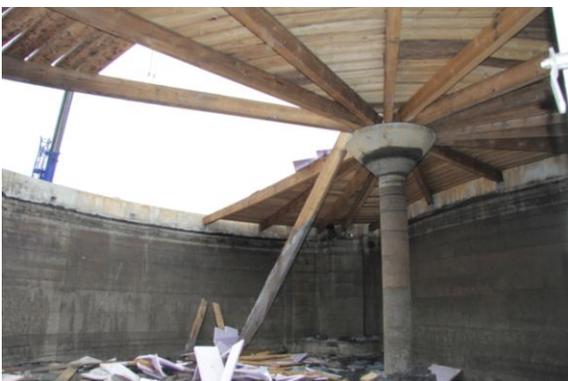
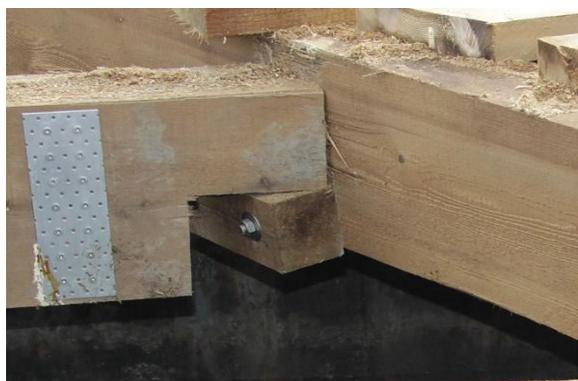
Failure of several roof joists of a combination biogas vessel after about 1.5 years of service. Breakage of the joists and slippage off the holders. Distinct design defects.

Figures 15-18: Different damage cases

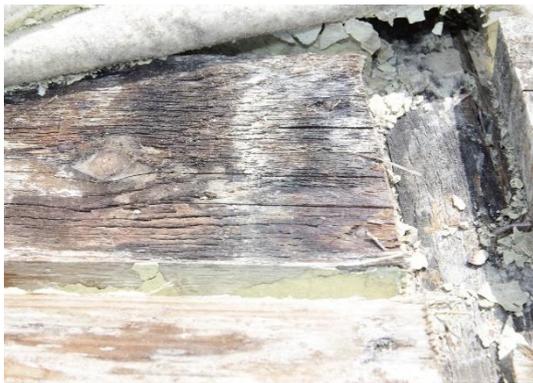
Figure 19: Blackish, frayed surface

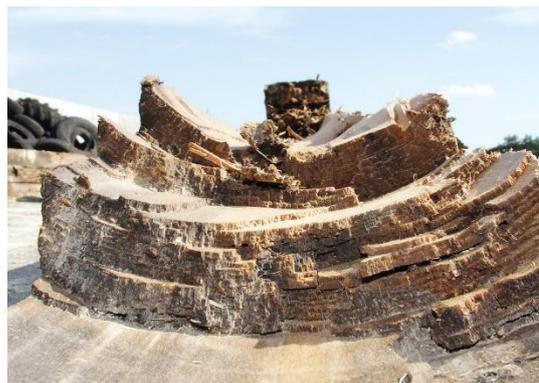
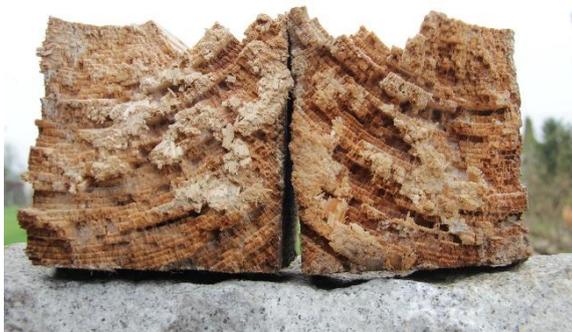
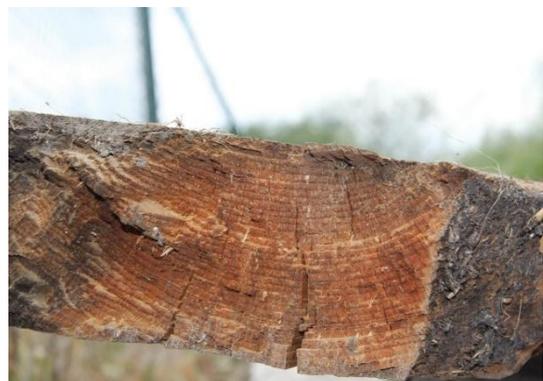
Figures 20-23: Extremely short breakages

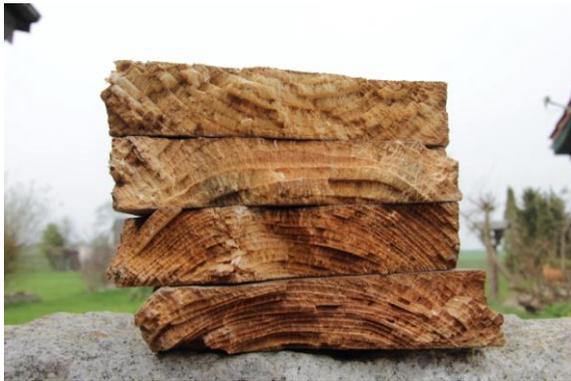
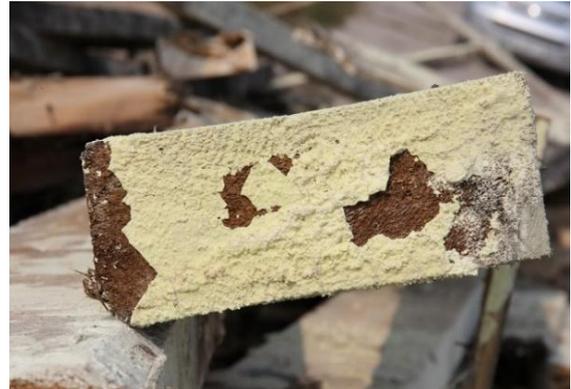
Figure 24: Sulfur deposits, from thin and crusty...

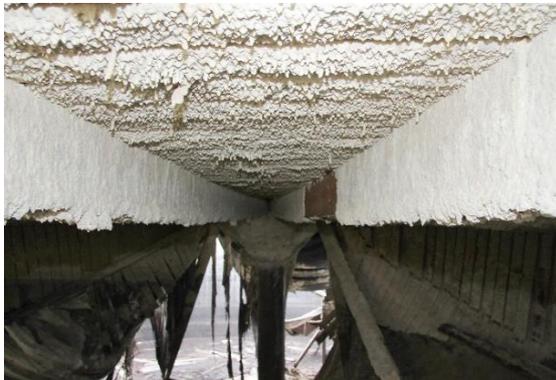
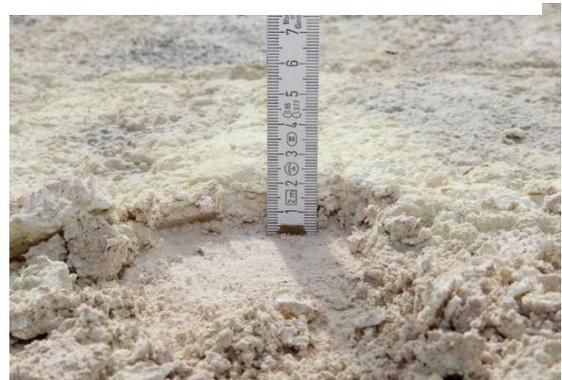
Figure 25-26: ... to a thickness of several centimeters

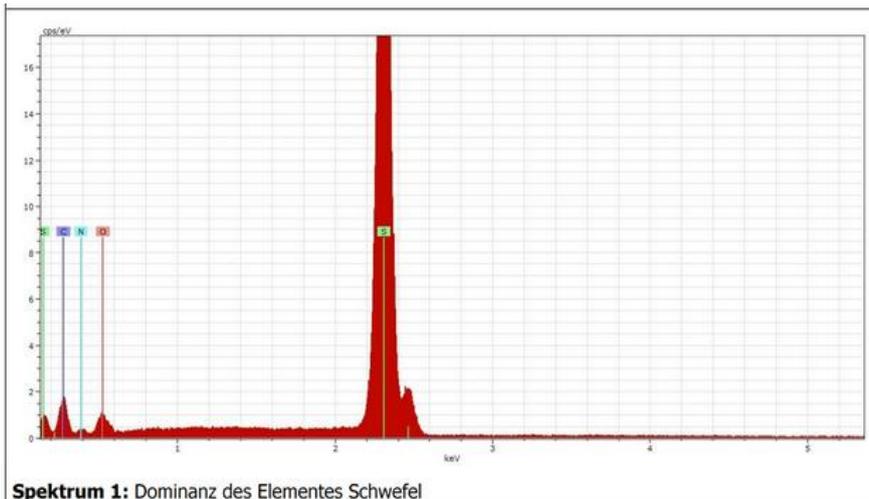
The REM/EDX (scanning electron microscopic energy dispersive X-ray analysis) examinations of the deposits showed a distinct dominance of sulfur in the yellow deposits whereas wooden parts that had had contact with the digestion substrate proved to consist of a mixture of several elements.

Figure 27: Analysis of the yellow deposits

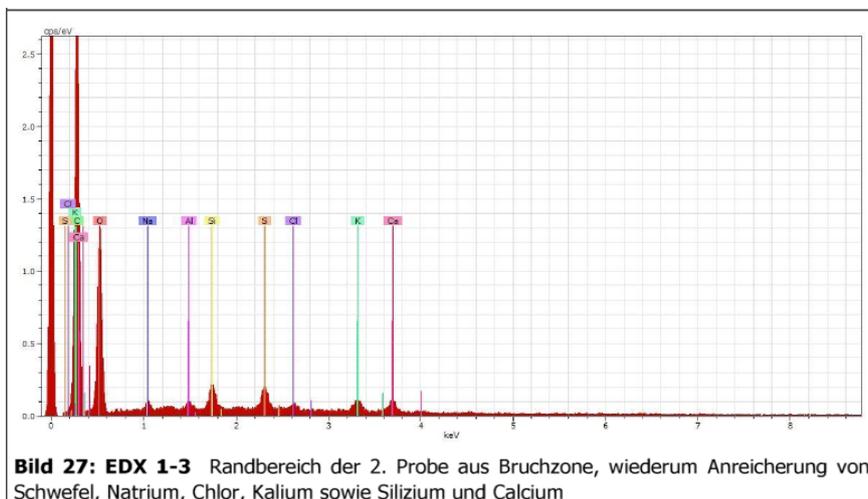
Figure 28: Analysis of a rafter after extended exposure to digestion substrate

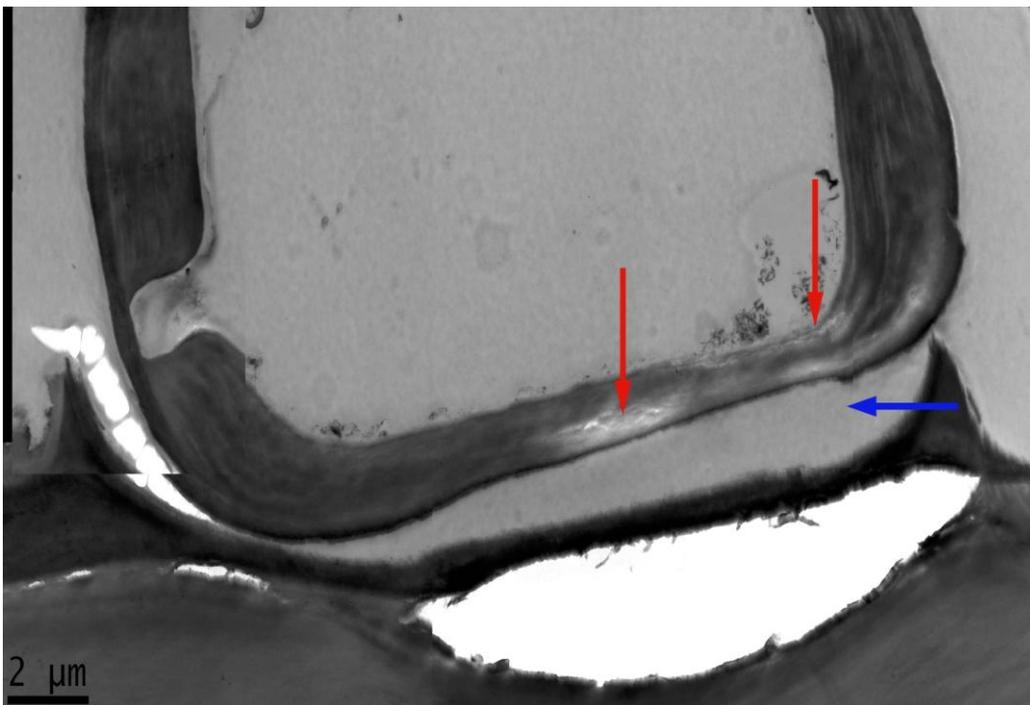
Looking at the results of the microscopic examinations obtained so far (incident light and transmission electron (TEM) microscopy), damage to the so called middle lamella is responsible for the dissolution of the association of cells. A middle lamella is a thin plasma-like layer of pectins between adjoining plant cells. This structure causes adjoining cells virtually to stick together. The mechanism of this damage has not been understood so far.

Figure 29: TEM image by Dr. Tobias Huckfeldt, Hamburg:  
Almost complete detachment in the area of the middle lamellas /S1 (←) also delicately structured modifications of the cell wall (↓). (The white areas are artefacts), Source: Claudia von Laar

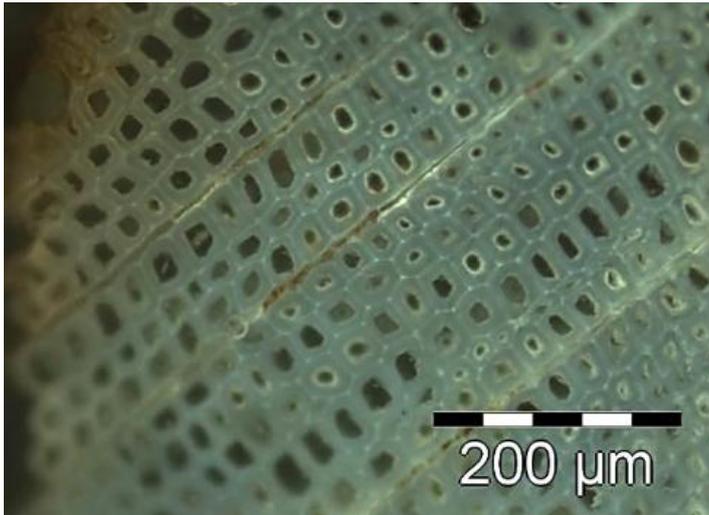
Figure 30: Light-microscopic image by Dr. Messal with visible dissolutions of associations of cells and immigrated substrate

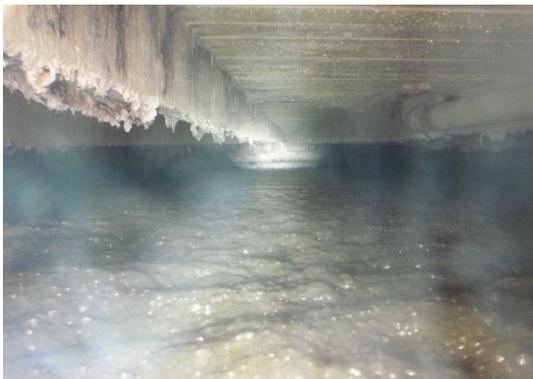
Figure 31: Service class 3???

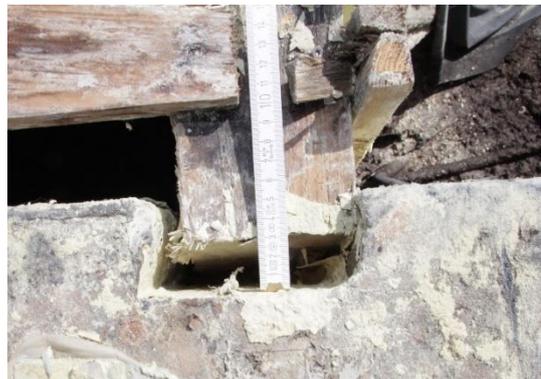
Figure 32: Support depth: 8 cm calculated, 5 cm theoretical, 2 cm in practice

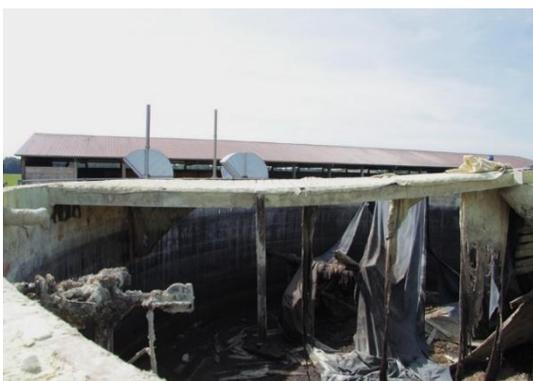
Figure 33: Heavy sag

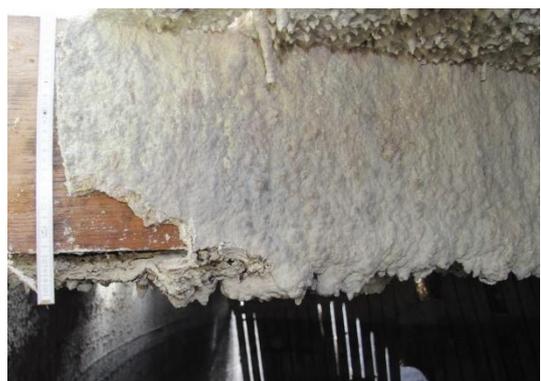
Figure 34: Extensive wet deposits
